# Field Report

Project Name: Locust Hill Development – Paving and Drainage Improvement Project

Project Number: 19-024 Field Visit Date: 10/16/2020

20-194 - Locust Hill Development – Paving and Drainage Improvement Project  
Construction Observations October 16, 2020

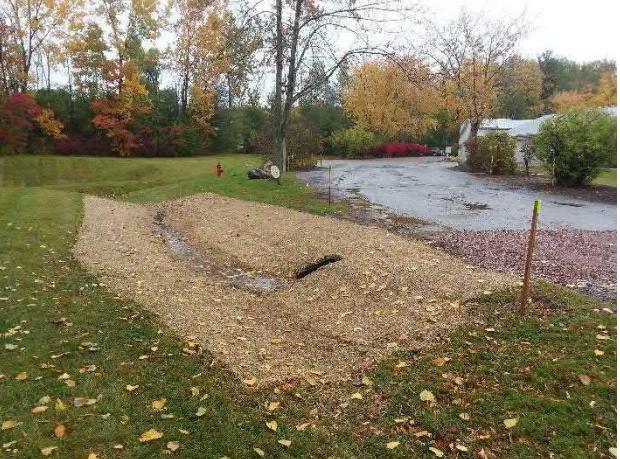
<p>Newly installed 12" HDPE culvert near Units 411-417. The swale has been installed, graded, seeded, and mulched.</p>	<p>This new 6" PVC drainage pipe has been installed. The area surrounding the outlet has been graded, seeded, and mulched.</p>

1. The 12" PVC pipe that crosses under the road near Units 411-417, which had been installed at the time of my last visit, had it's associated swale trenched out properly, we graded, and was seeded and mulched.

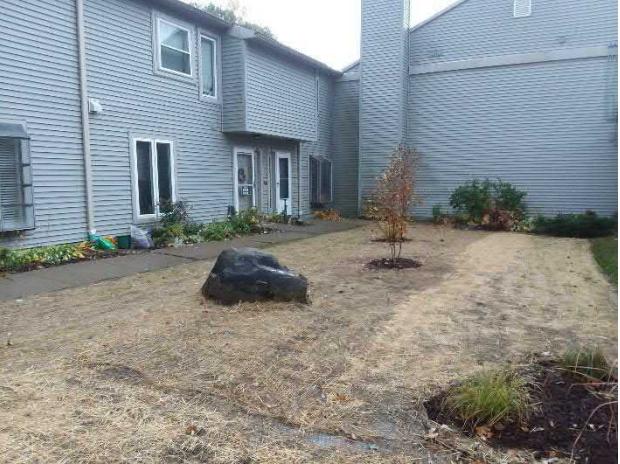
<p>The drainage associated with the courtyard between Units 355-361 and 363-369 has been completed and the lawn areas seeded and mulched.</p>	<p>CB 13 has been replaced and is functioning properly.</p>

3. The courtyard mentioned above has been completed with all of the roof drains tied in. This area has also been seeded and mulched.
4. CB 13 has been replaced and is functioning properly.

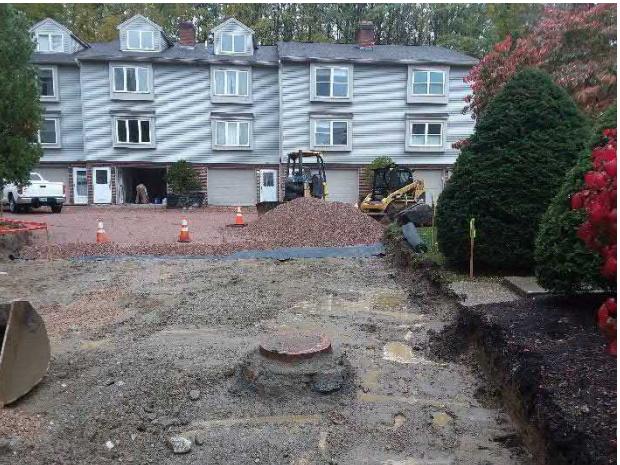
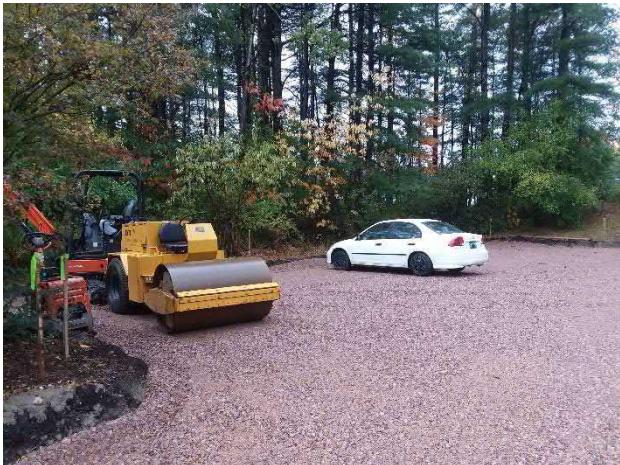
5. The area in front of Units 262-276 has started to have new subbase laid down. This includes the area of 8 parking spots for these units and is currently extended to approximately a few feet before the sidewalk that extends from Units 281-287 to the road.

<p>Subbase has begun to be laid down starting in front of Units 262-276.</p>	<p>The subbase has been laid down in the parking spaces across from Units 262-276.</p>

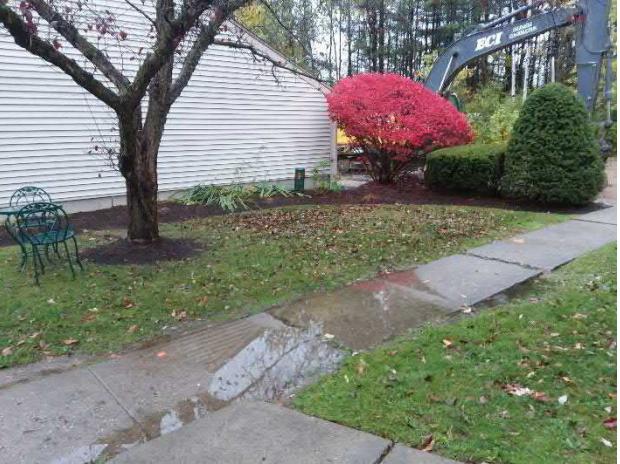
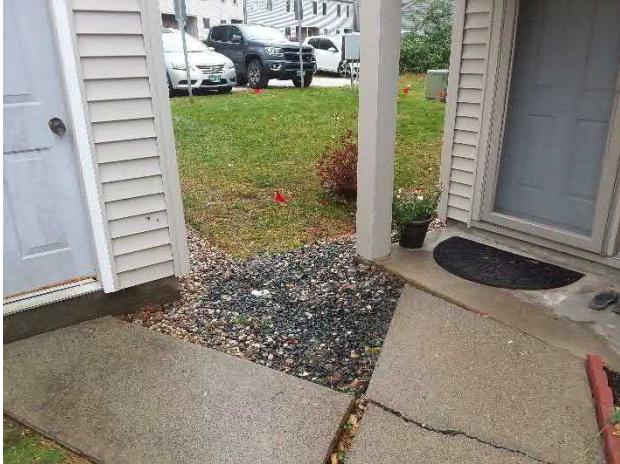
6. I noticed some ponding on the sidewalk that extends north easterly from Units 281-287 and took note of the drain in front of the eastern most Unit of the building.

Ponding on the sidewalk in front of Units 281-287	Drain in front in the door on the easternmost end of Units 281-287.

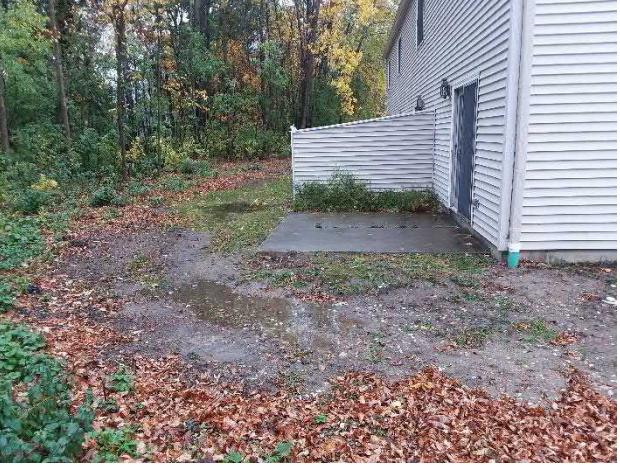
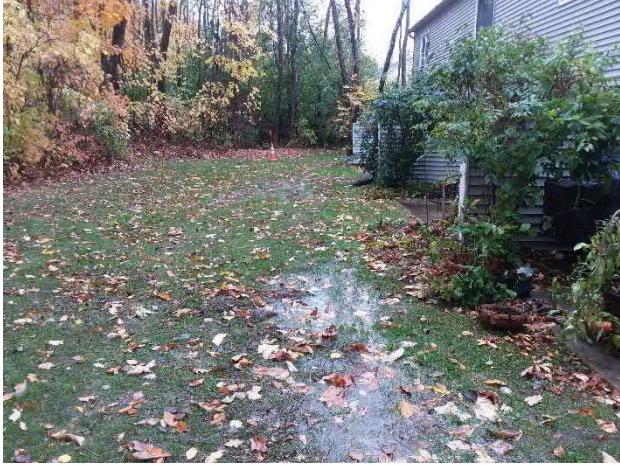
7. The rear of units 190-196 had small, but noticeable areas of ponding.
8. The rear of units 170-176 had small, but noticeable areas of ponding.

Ponding on the eastern side of Units 190-196 in the rear of the building.	Ponding behind Units 170-176 in the rear of the building.
